TECHNICAL MEMORANDUM

SUBJECT: Himco Dump Site visit, November 9, 1989

SITE VISIT CHECKLIST

PHOTO LOG OF THE HIMCO SITE VISIT - NOVEMBER 9, 1989

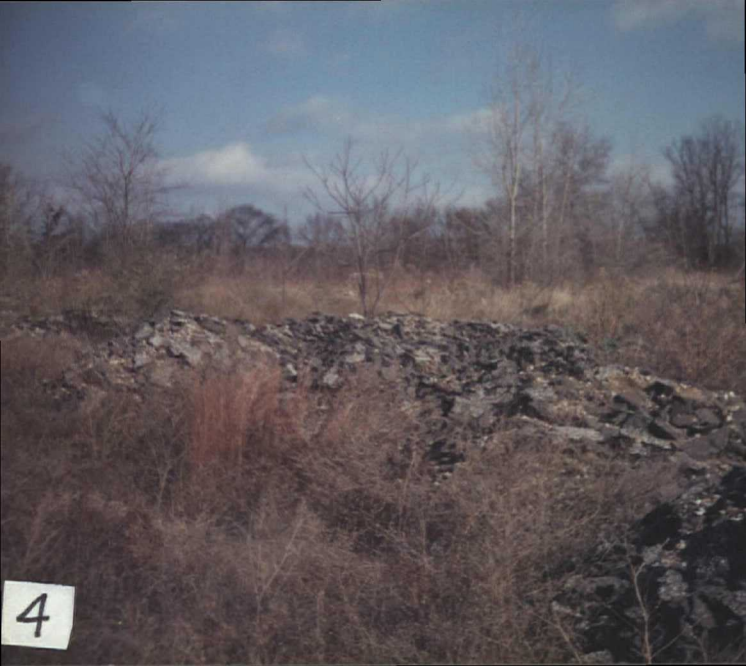
- 1 Entrance gate (locking) and access road to site
- 2 Berm adjacent to entrance gate
- 3 Concrete debris near gate
- 4 Asphalt piled alongside access road

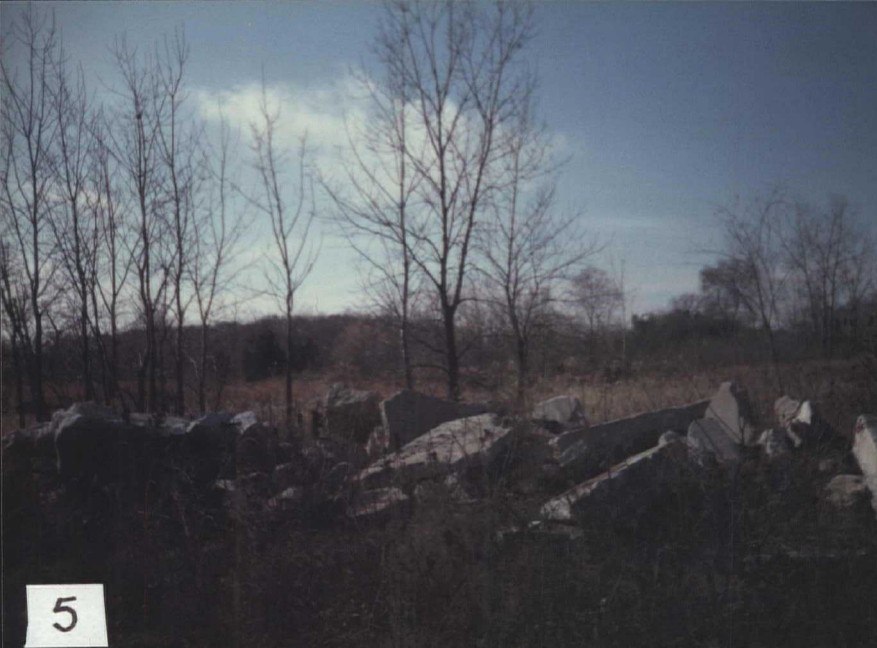
- 5 Concrete piled alongside access road
- 6 Concrete piled alongside access road
- 7 More asphalt piled alongside access road
- 8 More asphalt piled alongside access road

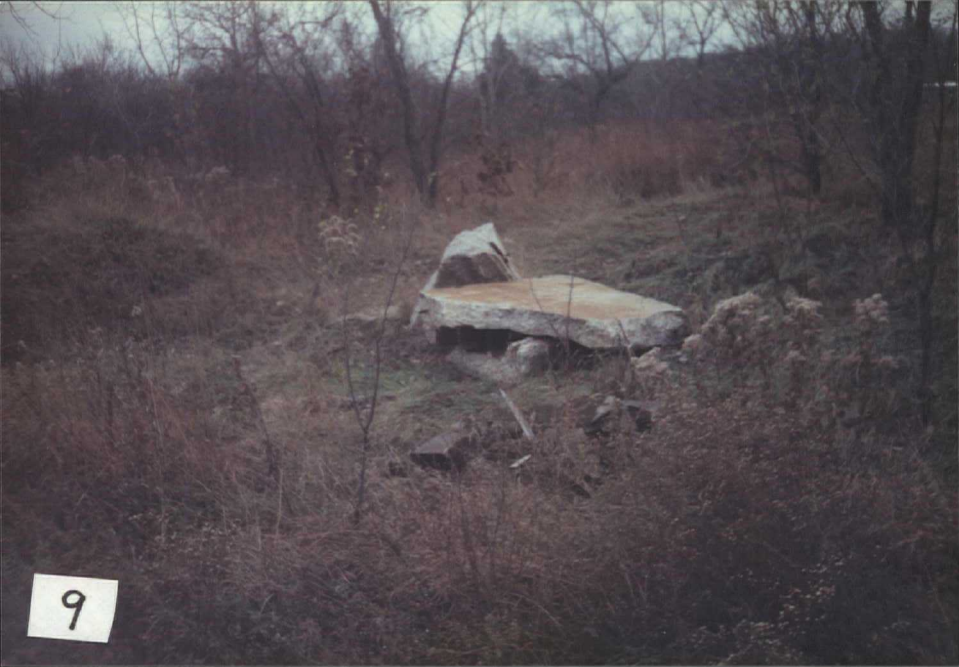
- 9 Concrete debris
- 10 Sheet metal debris
- 11 Area of poor cover, garbage exposed
- 12 Area of sparse vegetation
- 13 Area of pour cover, calcium sulfate @ surface

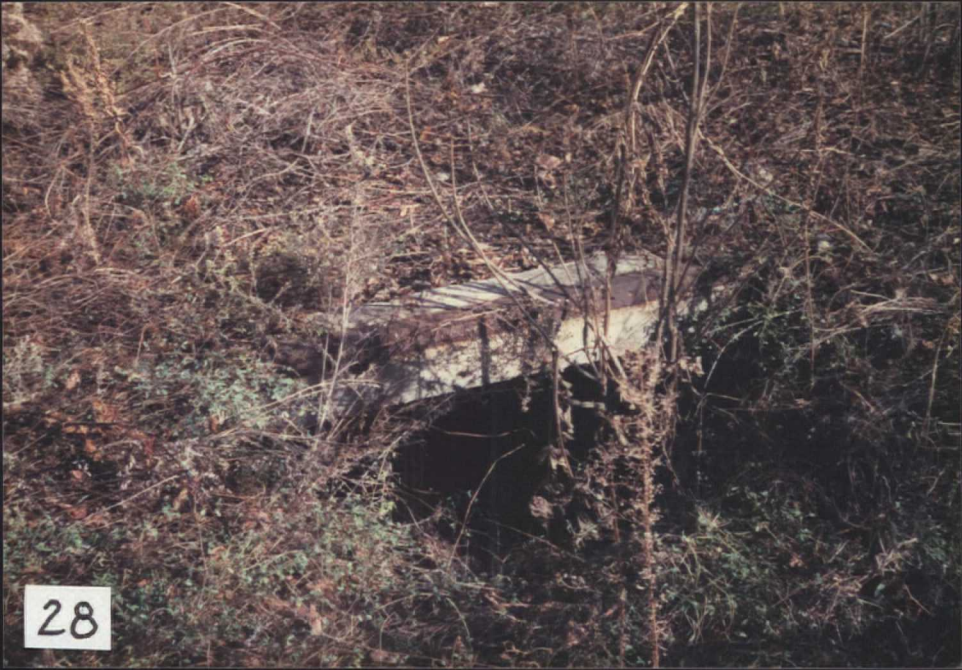
- 27 Area of poor final cover
- 28 Remnants of truck scale (?) near gravel pit
- 29 View north of gravel pit pond
- 30 Concrete building and utility pole near gravel pit

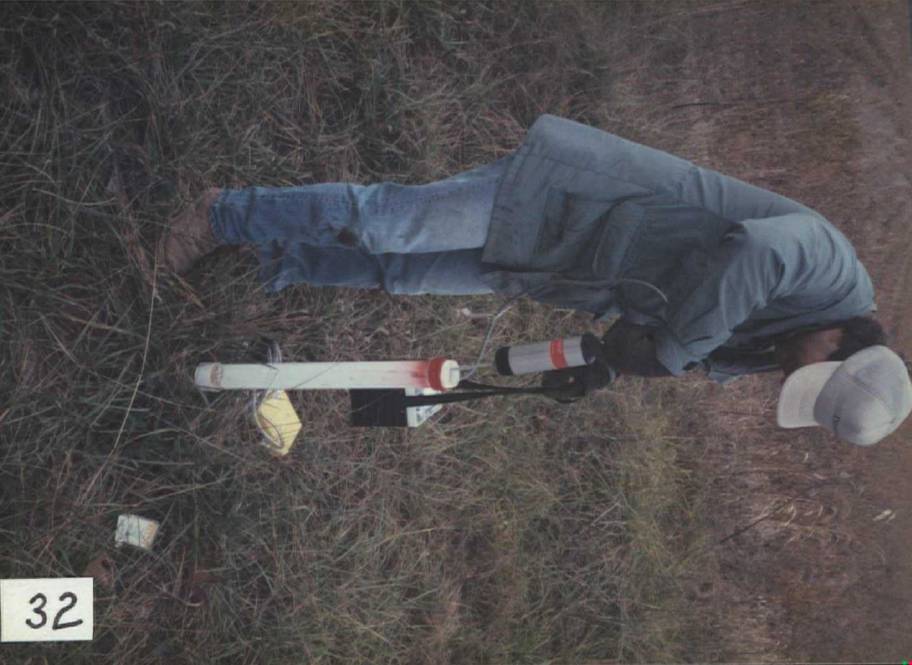
- 31 USGS well nest south of landfill
- 32 Testing USGS well for VOCs
- 33 Testing USGS well for VOCs
- 34 USGS well nest south of landfill
- 35 USGS flush well east of landfill

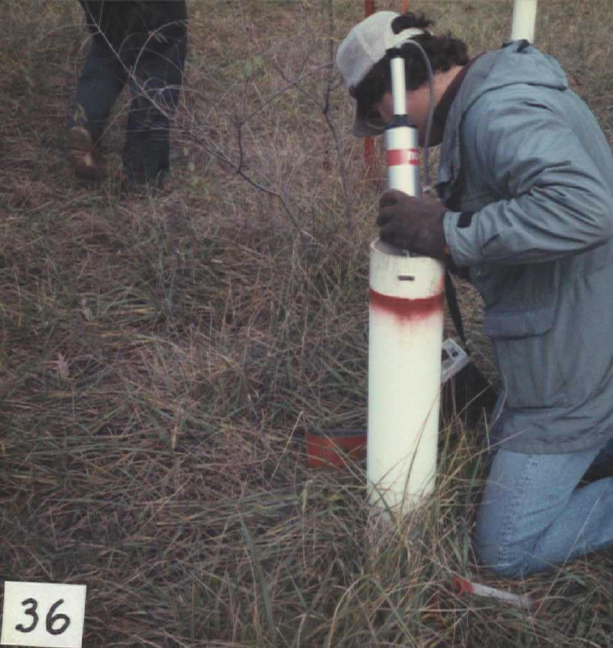
- 36 Checking USGS well for VOCs
- 37 Moss growing on calcium sulfate crystals
- 38 Wetland vegetation and forest at north edge of fill
- 39 Drainage of the landfill cover

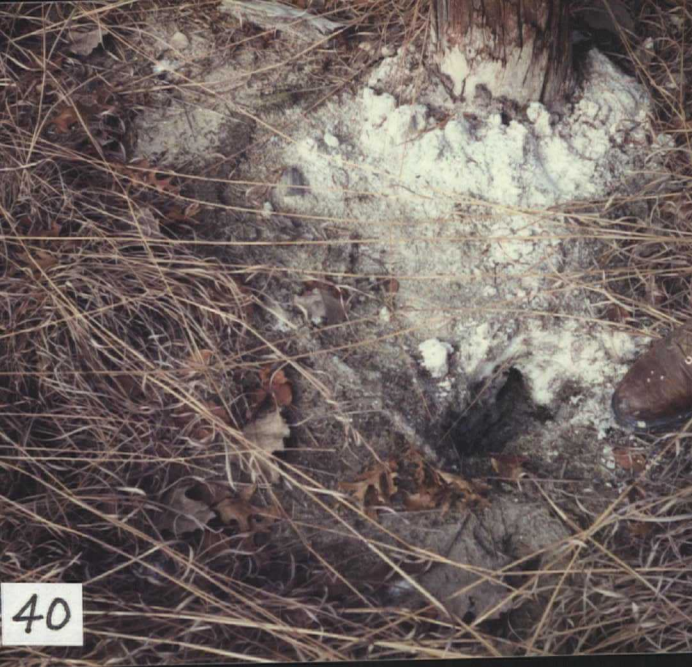
- 40 Calcium sulfate adjacent to gopher hole
- 41 Landfill cover vegetation looking south
- 42 A cavern formed by a burrowing animal and rainwater
- 43 Western side of landfill, remnants of row crops

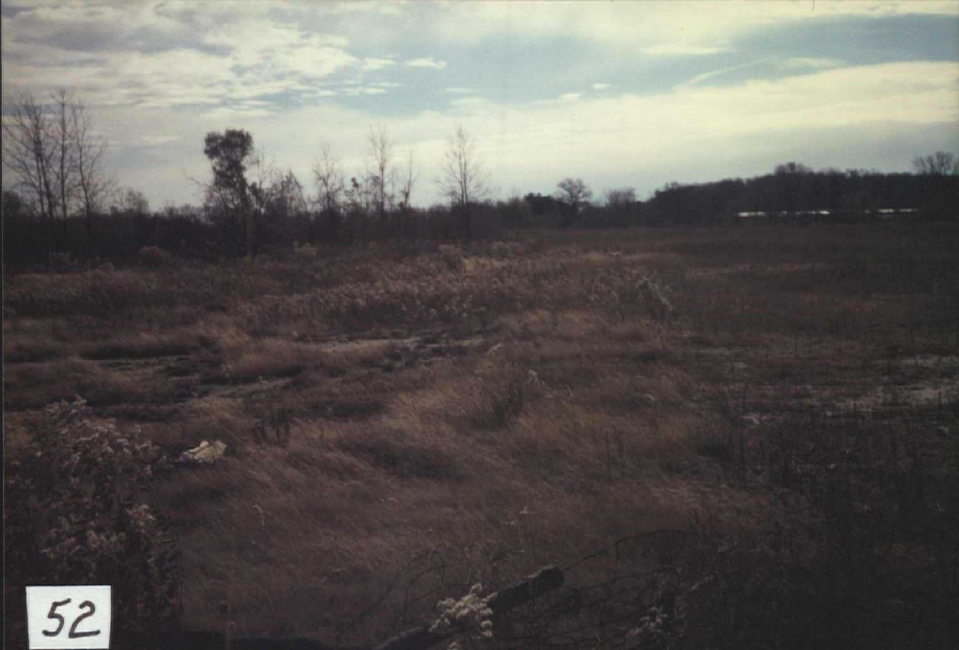
- 52 Drainage area on landfill cover
- 53 Drainage area on landfill cover
- 54 Moss growing on calcium sulfate crystals
- 55 Berm with calcium sulfate on southern edge of landfill

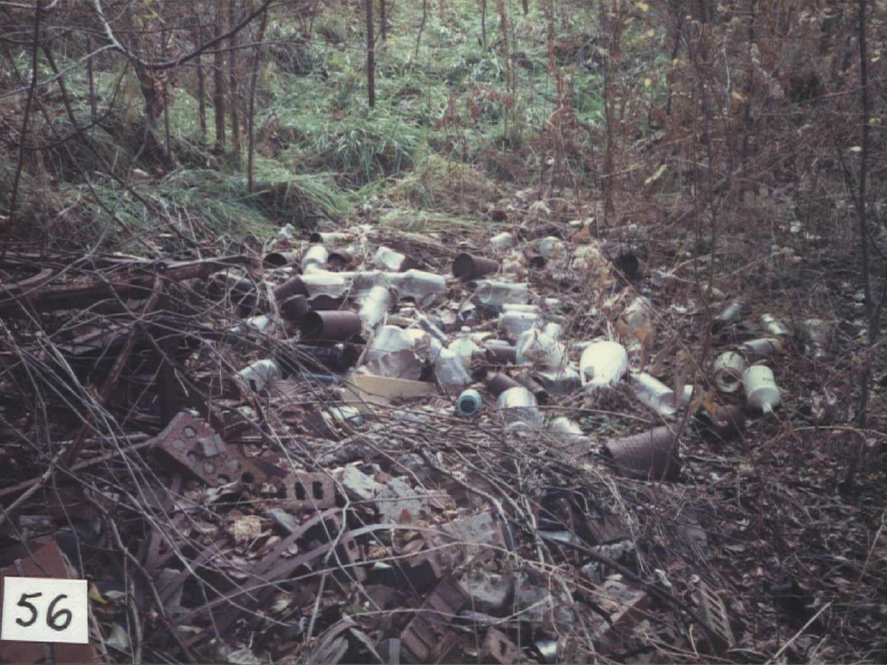
- 56 Bottles, cans, sheet metal, misc. debris southern edge of landfill
- 57 Underground storage tank disposed of on landfill cover
- 58 Residences near southwest corner of landfill

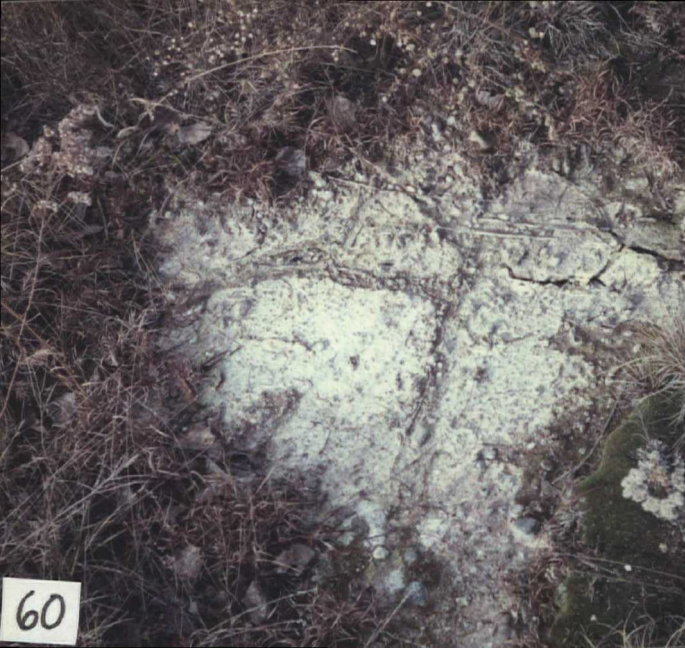
- 59 Drainage area with calcium sulfate exposed
- 60 Drainage area with calcium sulfate exposed
- 61 Landfill cover looking east
- 62 Landfill cover looking east

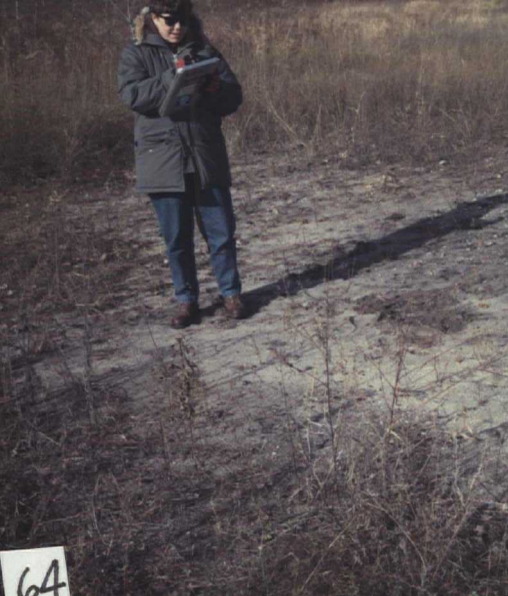
- 63 Area of poor cover and sparse vegetation
- 64 Area of poor cover and sparse vegetation
- 65 Wetland area adjacent to western edge of landfill
- 66 Wetland area adjacent to western edge of landfill
